**Flood Control Project Maintenance  
Levee Inspections**

**Maintenance Issue Types Only, Levee Inspection Report By Mile - Spring 2020**

**Sutter Maintenance Yard Maintenance Area 0013**

Waterway	Bank	Unit Miles	Inspection Start/End	Inspector
Unit No. 01 Cherokee Canal	Right	18.19	04/09/2020 04/09/2020	Makar Sokol

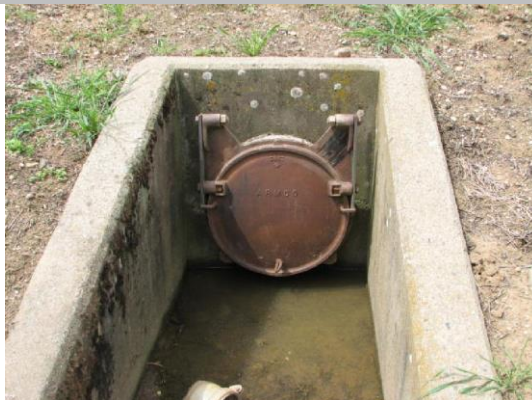
Photo 2 of 3 : UCIP\_SP\_2020\_54938\_66688.jpg

View of WS headwall and flap gate.

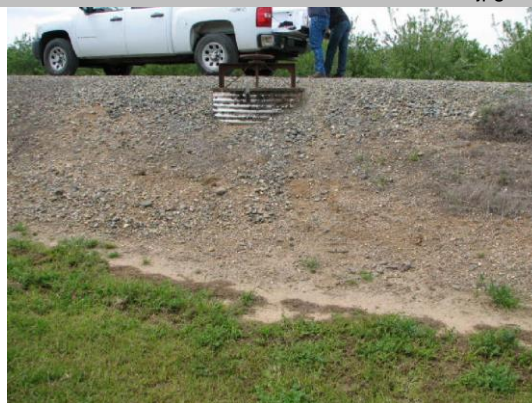
Photo 2 of 3 : UCIP\_SP\_2020\_54939\_66699.jpg

Corrugated metal riser with slide gate located on WS slope.

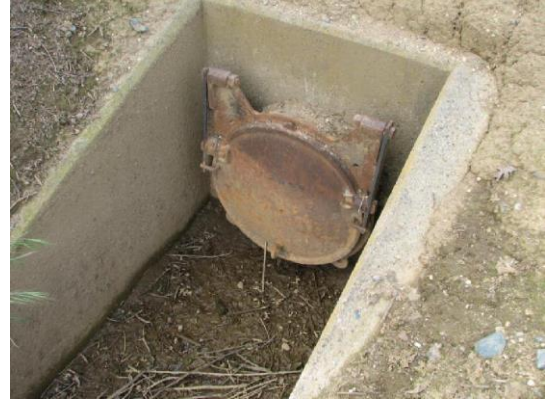
Photo 2 of 3 : UCIP\_SP\_2020\_54942\_66714.jpg

Flap gate at WS.

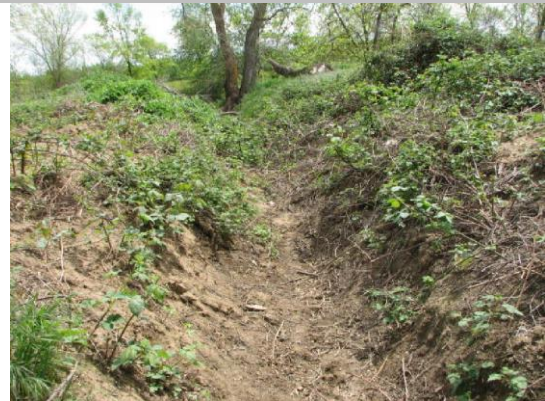
Photo 3 of 3 : UCIP\_SP\_2020\_54942\_66711.jpg

View of channel.

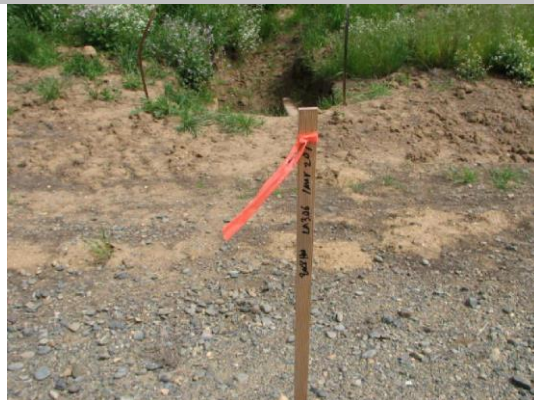
Photo 2 of 3 : UCIP\_SP\_2020\_54943\_66716.jpg

WS levee slope.

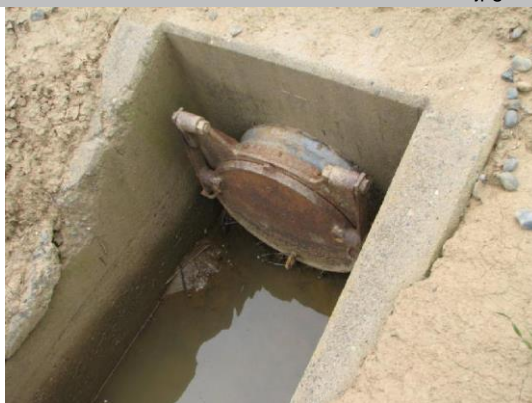
Photo 2 of 3 : UCIP\_SP\_2020\_54944\_66724.jpg

Flap gate on WS.

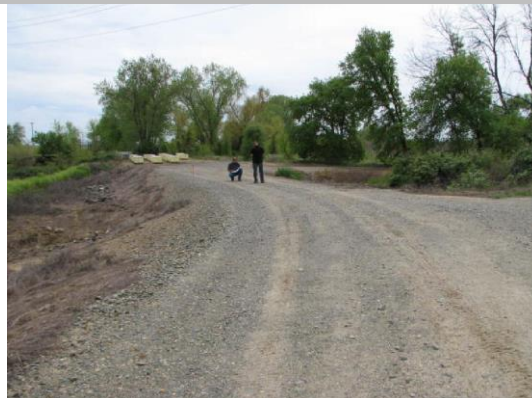
Photo 1 of 3 : UCIP\_SP\_2020\_54945\_66731.jpg

Overview of levee crown at crossing.

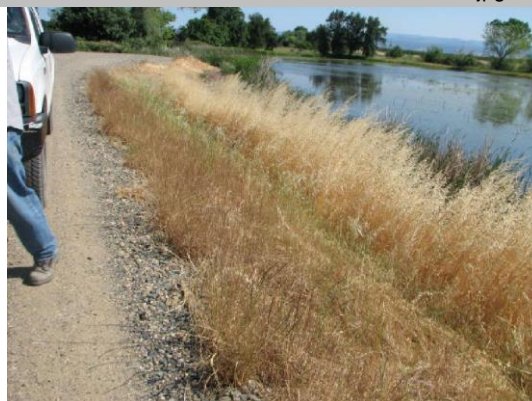
Photo 2 of 3 : UCIP\_SP\_2020\_54946\_66738.jpg

WS slope covered by dense vegetation.

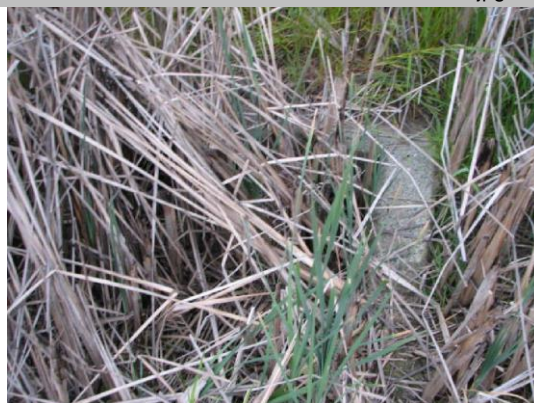
Photo 2 of 3 : UCIP\_SP\_2020\_54947\_66741.jpg

WS flap gate blocked by debris.

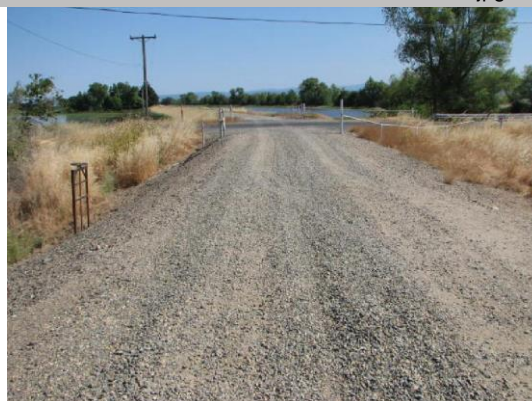
Photo 1 of 3 : UCIP\_SP\_2020\_54949\_66752.jpg

Comment Code						
Inspector Comment						
DS_ID:16341 FS_ID:54949 EP_NO: N/A Repair Type: Non-Urgent Crossing Status: Found UCIP Comments: 08/26/2019 Record has been updated from No Action Needed to Non-Urgent, no permit has been found authorizing pipe. Pipe is scheduled to be lined. (O. Magana - DWR UCIP, A. Freitag - DWR Sutter Yard)06/14/2017 WS flap gate is shut but blocked by sediment- needs to be dug out. LS slide gate has some minor sediment built up against it. Pipe has been selected to be internally cleaned and inspected as part of the DMP project. (DWR Sutter Yard- A.Freitag)11/16/2016 Crossing appears to be in good condition. (DWR Sutter Yard- A.Freitag)04/28/2016 Crossing appears to be in good condition.07/13/2015 Crossing appears in good condition. No noticeable issues to report.05/21/2014 Same as last inspection.12/02/2013 Same as last inspection.07/15/2013 Same as last inspection.04/18/2012 Minor debris on landside inlet. This crossing was listed in the USACE Periodic Inspection report as Corp's inspect ID#USACE_CESPK_M13D_2011_p_0189 for sediment and grass blocking WS and LS. FIELD_STRUCT_DESC: 36-inch corrugated metal drainage pipe through the levee, 9.1 feet below the crown. Flap gate on the waterside (WS) end. Slide gate located on the landside (LS) end. Concrete "U" headwalls on both ends. [Additional Reference(s): DWR Levee Log, 1993 (HLM 4.43). USACE Sacramento O&M Manual 519, June 1962 (HLM 4.43), As-built DWG No. 50-4-3608, Sheet No. 3608/19.1, STA 891+52E, page 20 of 28 electronic file, listed as 36-inch CMP; As-built DWG No 50-4-3037 referenced not available] FS Date: 8/26/2019 12:26:00 PM

Overview of levee crown at crossing looking upstream.

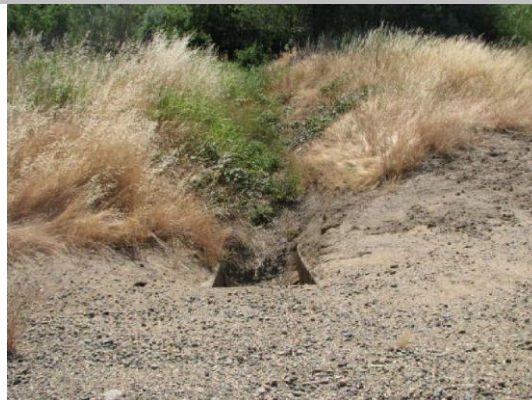
Photo 2 of 3 : UCIP\_SP\_2020\_54949\_66753.jpg

View of WS slope and toe.

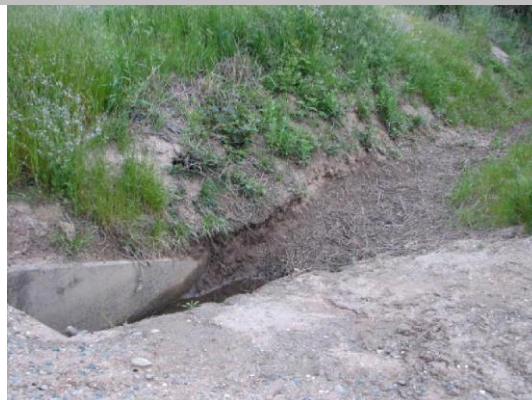
Photo 3 of 3 : UCIP\_SP\_2020\_54949\_66750.jpg

View of WS.

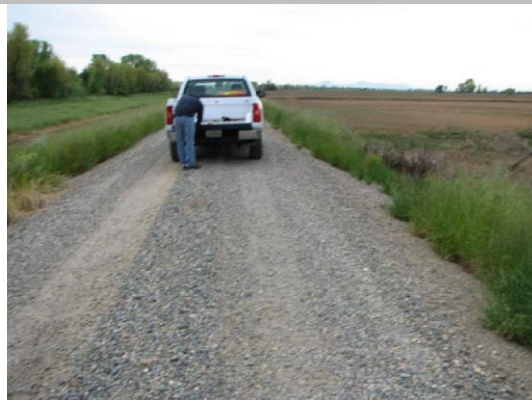
Photo 1 of 3 : UCIP\_SP\_2020\_54950\_66756.jpg

Comment Code						
Inspector Comment						
DS_ID:16355 FS_ID:54950 EP_NO: N/A Repair Type: Non-Urgent Crossing Status: Found UCIP Comments: 08/26/2019 Record has been updated from No Action Needed to Non-Urgent, no permit has been identified for this pipe. Pipe is scheduled to be lined. (O. Magana - DWR UCIP, A. Freitag - DWR Sutter Yard)06/14/2017 WS flap gate is submerged and appears to be half buried by sediment. LS slide gate is fully submerged on the edge of the rice field. Pipe has been selected to be internally cleaned and inspected as part of the DMP project. (DWR Sutter Yard- A.Freitag)11/16/2016 Crossing appears to be in good condition. (DWR Sutter Yard- A.Freitag)04/28/2016 Crossing appears to be in good condition.07/13/2015 LS screw gate was completely submerged but crossing appears to be in good condition.05/21/2014 Same as last inspection.12/02/2013 Same as last inspection.07/15/2013 No signs of burrowing activity on this inspection.04/18/2012 Burrow activity near crossing, burrow holes present on WS slope. FIELD_STRUCT_DESC: 24-inch corrugated metal drainage pipe through the levee 7.7 feet below the crown. Flap gate on the waterside (WS) end. Slide gate located on the landside (LS) end. Concrete "U" headwalls on both ends. [Additional Reference(s): DWR Levee Log, 1993 (HLM 4.94). USACE Sacramento O&M Manual 519, June 1962 (HLM 4.94), As-built DWG No. 50-4-3608, Sheet No. 3608/18, STA 865+00E, page 19 of 28 electronic file, listed as 24-inch CMP; As-built DWG No 50-4-3037 referenced not available] FS Date: 8/26/2019 12:28:00 PM

Overview of levee crown at crossing looking downstream at right bank of Cherokee Canal.

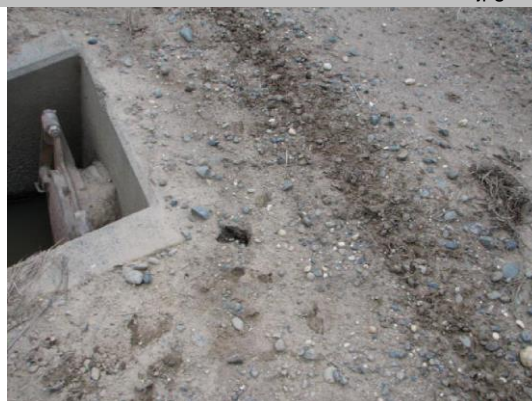
Photo 2 of 3 : UCIP\_SP\_2020\_54950\_66758.jpg

Burrow activity on WS slope.

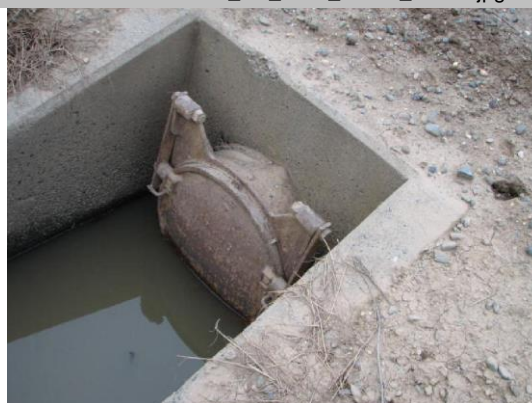
Photo 3 of 3 : UCIP\_SP\_2020\_54950\_66755.jpg

View of WS flap gate.

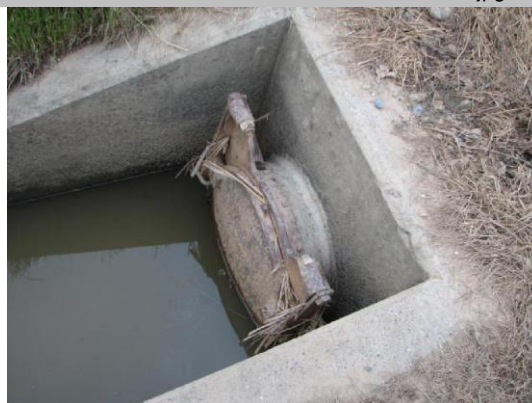
Photo 2 of 3 : UCIP\_SP\_2020\_54951\_66760.jpg

WS Flap Gate

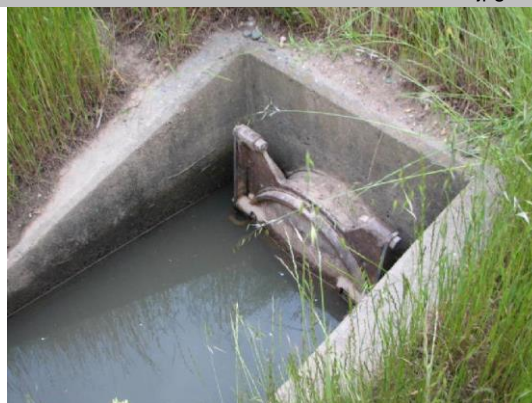
Photo 3 of 3 : UCIP\_SP\_2020\_54952\_66768.jpg

View of WS flap gate.

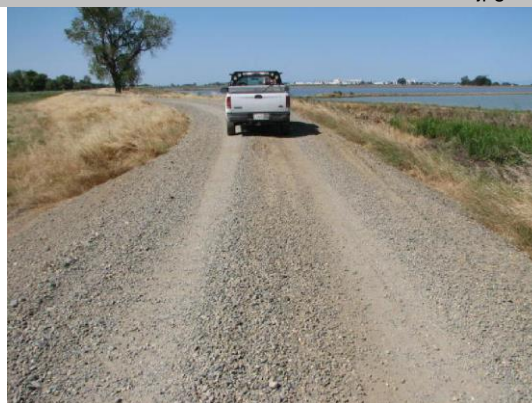
Photo 1 of 3 : UCIP\_SP\_2020\_54957\_66793.jpg

DS\_ID:16359  
FS\_ID:54957  
EP\_NO: N/A  
Repair Type: Non-Urgent  
Crossing Status: Found  
UCIP Comments: 08/26/2019 Record remains Non-Urgent, no permit has been identified authorizing pipe. Pipe is scheduled to be lined. (O. Magana - DWR UCIP, A. Freitag - DWR Sutter Yard)06/14/2017 WS Flap gate is completely buried- needs to be dug out. LS is blocked off by flashboards that are partially buried. Pipe has been selected to be internally cleaned and inspected as part of the DMP project. (DWR Sutter Yard- A.Freitag)11/16/2016 WS still completely buried. (DWR Sutter Yard- A.Freitag)04/28/2016 WS gate and headwall are buried. Only the top of the headwall was visible. LS appeared ok.07/13/2015 Both the LS screw gate and WS flap gate are completely buried.05/21/2014 Same as last inspection.12/02/2013 Same as last inspection.07/15/2013 Slopes have been cleared of vegetation and are in good condition. WS headwall and flap gate are fully covered in debris and not visible. Need to clear.04/18/2012 High sedimentation build up at WS and LS headwall. Limited inspection due to dense vegetation on WS and LS slope. Need photo of cleared WS and LS slopes. This crossing was listed in the USACE Periodic Inspection report as Corp's inspect ID#

USACE\_CESPK\_M13D\_2011\_p\_0210 for WS gate submerged.  
FIELD\_STRUCT\_DESC: 24-inch corrugated metal drainage pipe through the levee, 9.2 feet below the crown. Flap gate on the waterside (WS) end. Concrete "U" headwalls on both ends. [Additional Reference(s): DWR Levee Log, 1993 (HLM 5.73). USACE Sacramento O&M Manual 519, June 1962 (HLM 5.73), As-built DWG No. 50-4-3608, Sheet No. 3608/18, STA 820+50E, page 19 of 28 electronic file, listed as 24-inch CMP; As-built DWG No 50-4-3037 referenced not available]  
FS Date: 8/26/2019 12:38:00 PM

Overview of levee crown at crossing looking downstream.

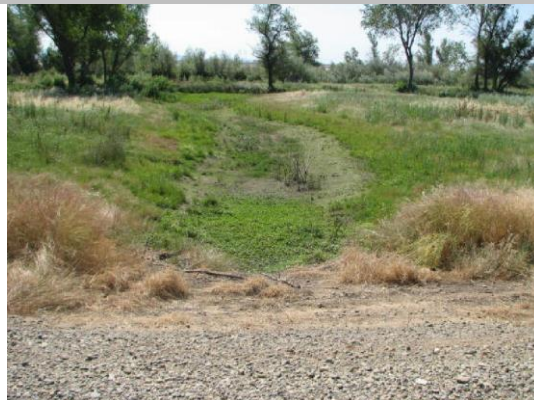
Photo 2 of 3 : UCIP\_SP\_2020\_54957\_66794.jpg

View of WS slope and toe.

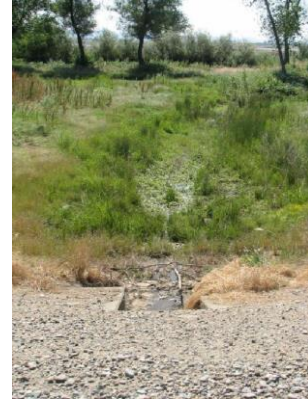
Photo 2 of 3 : UCIP\_SP\_2020\_54958\_66801.jpg

View of WS slope and toe.

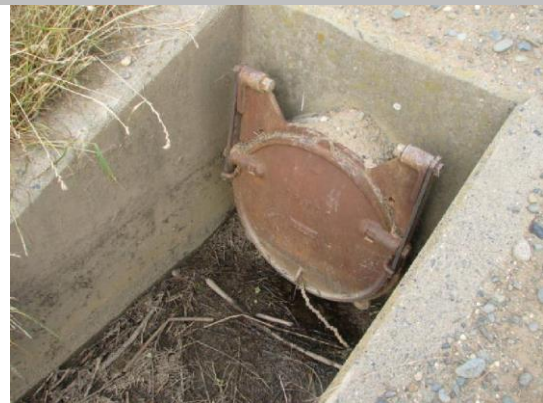
Photo 3 of 3 : UCIP\_SP\_2020\_54958\_66799.jpg

Flap gate WS

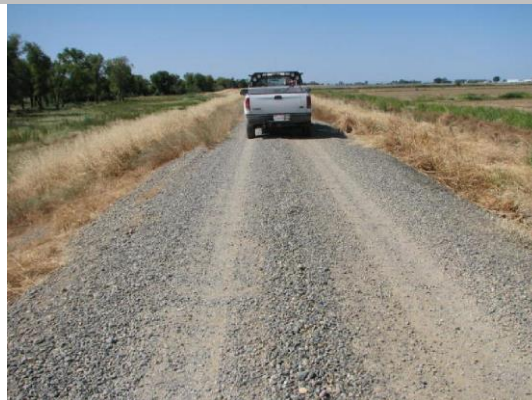
Photo 1 of 3 : UCIP\_SP\_2020\_54959\_66808.jpg

Comment Code						
Inspector Comment						
DS_ID:16361 FS_ID:54959 EP_NO: N/A Repair Type: Non-Urgent Crossing Status: Found UCIP Comments: 08/26/2019 Record remains Non-Urgent, no permit has been identified authorizing pipe. Pipe is scheduled to be lined. (O. Magana - DWR UCIP, A. Freitag - DWR Sutter Yard)06/14/2017 WS appears to be in good condition. LS slide gate is buried and submerged. Pipe has been selected to be internally cleaned and inspected as part of the DMP project. (DWR Sutter Yard-AFreitag)11/16/2016 LS screw gate is buried and non-operational. (DWR Sutter Yard- AFreitag)04/28/2016 LS screw gate is still completely buried. 07/13/2015 LS screw gate is completely buried.05/21/2014 Same as last inspection.07/15/2013 WS slope has been cleared of vegetation and is in good condition. LS screw gate is still buried.12/02/2013 Same as last inspection.04/18/2012 LS slide gate is buried. Pipe is not visible on LS toe. Limited inspection on WS slope due to dense vegetation. FIELD_STRUCT_DESC: 24-inch corrugated metal drainage pipe through the levee, 7.4 feet below the crown. Flap gate on the waterside (WS) end. Slide gate on the landside (LS) end. Concrete "U" headwalls on both ends. [Additional Reference(s): DWR Levee Log, 1993 (HLM 6.32). USACE Sacramento O&M Manual 519, June 1962 (HLM 6.34), As-built DWG No. 50-4-3608, Sheet No. 3608/18, STA 789+00E, page 19 of 28 electronic file, listed as 24-inch CMP; As-built DWG No 50-4-3037 referenced not available] FS Date: 8/26/2019 12:41:00 PM

Overview of levee crown at crossing looking downstream.

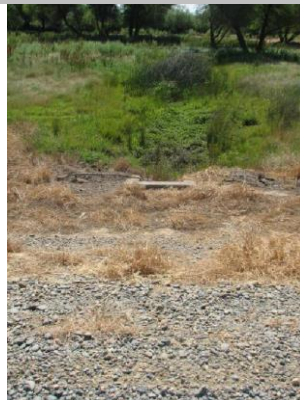
Photo 2 of 3 : UCIP\_SP\_2020\_54959\_66806.jpg

View of WS slope and toe.

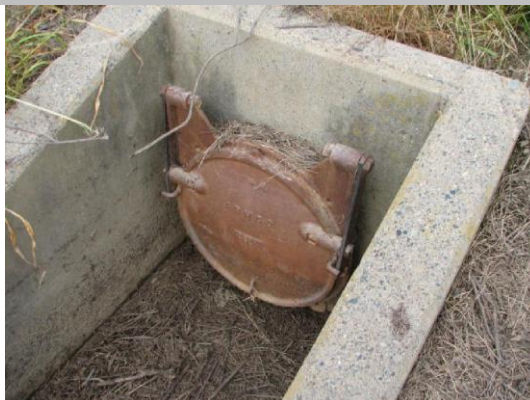
Photo 3 of 3 : UCIP\_SP\_2020\_54959\_66804.jpg

View of WS flap gate.

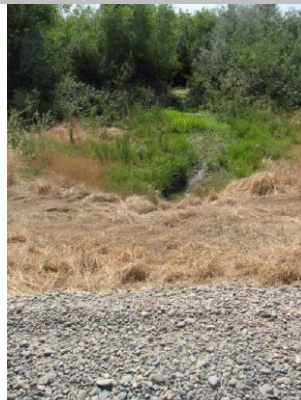
Photo 2 of 3 : UCIP\_SP\_2020\_54967\_66832.jpg

View of WS slope and toe.

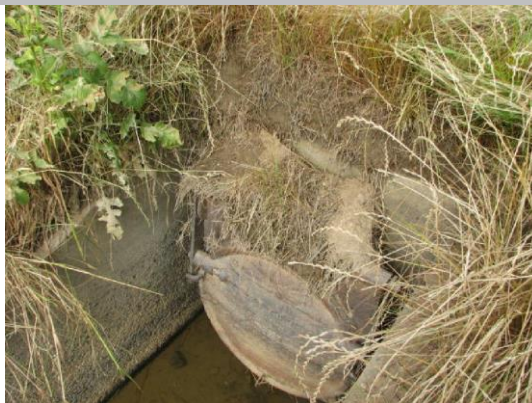
Photo 3 of 3 : UCIP\_SP\_2020\_54967\_66837.jpg

WS Flap Gate

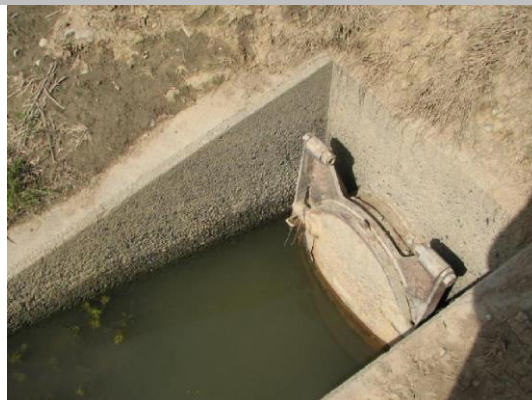
Photo 3 of 3 : UCIP\_SP\_2020\_56089\_66842.jpg

WS Flap Gate

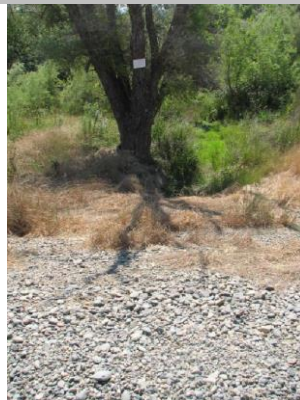
Photo 2 of 3 : UCIP\_SP\_2020\_54969\_66851.jpg

WS view of slope and channel.

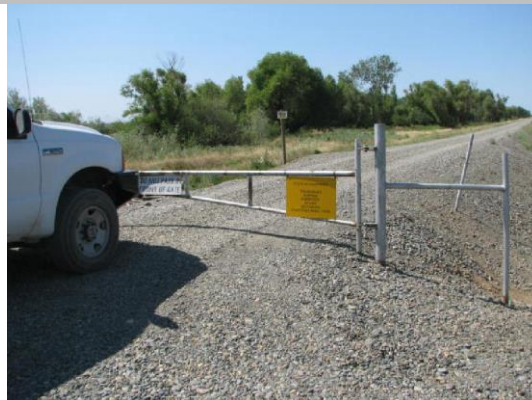
Photo 1 of 3 : UCIP\_SP\_2020\_56090\_66867.jpg

Comment Code						
Inspector Comment						
DS_ID:16320 FS_ID:56090 EP_NO: N/A Repair Type: Non-Urgent Crossing Status: Found UCIP Comments: 08/26/2019 Record has been updated from No Action Needed to Non-Urgent, no permit has been identified authorizing pipe. Pipe is scheduled to be lined. The following maintenance issues should be addressed: clear vegetation from LS inlet and repair CMP riser lid (safety measure). (O. Magana - DWR UCIP, A. Freitag - DWR Sutter Yard)06/14/2017 Debris down inside of WS riser. The rest of the crossing appears to be in good condition. Pipe has been selected to be internally cleaned and inspected as part of the DMP project. (DWR Sutter Yard- AFreitag)11/16/2016 Crossing appears to be in good condition. (DWR Sutter Yard- AFreitag)04/28/2016 Crossing appears to be in good condition.07/13/2015 The bottom of the entire pipe has about 8inch of sediment in it. Sediment is preventing the screw gate from fully closing. WS flap gate seems to be in good condition.05/21/2014 Same as last inspection.12/03/2013 Same as last inspection.07/15/2013 Same as last inspection. FIELD_STRUCT_DESC: 48-inch corrugated metal drainage pipe through the levee, 9.9 feet below the crown. Flap gate on the waterside (WS) end. Slide gate in corrugated metal pipe riser on the WS slope. Concrete "U" headwalls on both ends. Spillway grouted for 35 feet. [Additional Reference(s): DWR Levee Log, 1993 (HLM 7.76). USACE Sacramento O&M Manual 519, June 1962 (HLM 7.76), As-built DWG No. 50-4-3608, Sheet No. 3608/18, STA 714+28E, page 19 of 28 electronic file, listed as 48-inch CMP; As-built DWG No 50-4-3037 referenced not available] FS Date: 8/26/2019 1:06:00 PM

Overview of levee crown at crossing (past gate) looking D/S.

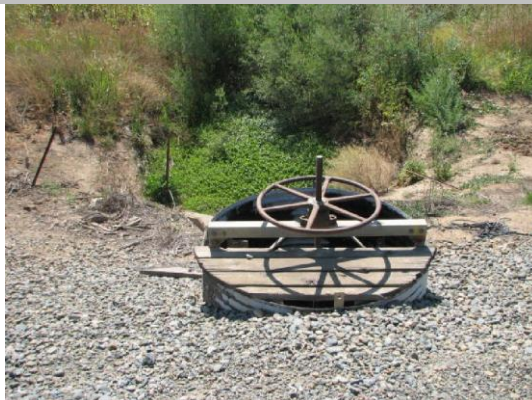
Photo 2 of 3 : UCIP\_SP\_2020\_56090\_66865.jpg

View of WS slope, corrugated metal riser with slide gate.

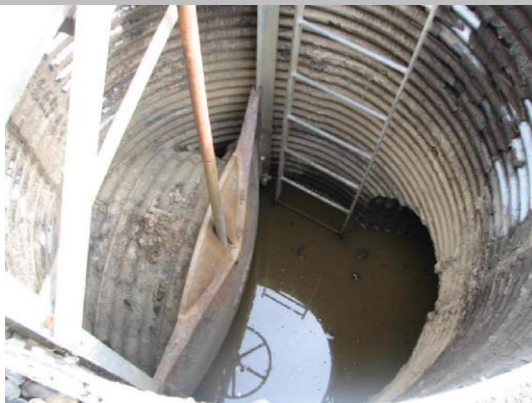
Photo 3 of 3 : UCIP\_SP\_2020\_56090\_66863.jpg

WS Slide gate

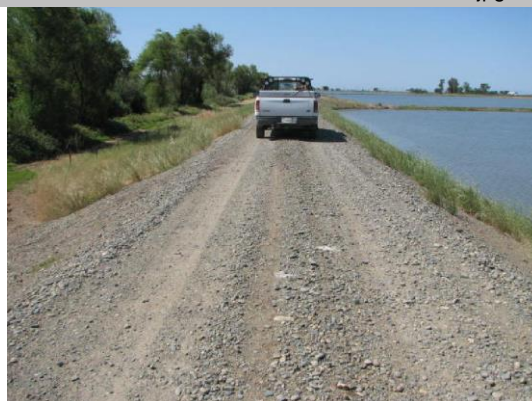
Photo 1 of 3 : UCIP\_SP\_2020\_54973\_66872.jpg

Comment Code						
Inspector Comment						
DS_ID:16321 FS_ID:54973 EP_NO: N/A Repair Type: Non-Urgent Crossing Status: Found UCIP Comments: 08/27/2019 Record has been updated from No Action Needed to Non-Urgent, no permit has been identified authorizing pipe. Pipe is scheduled to be lined. (O. Magana - DWR UCIP, A. Freitag - DWR Sutter Yard)06/14/2017 Crossing appears to be in good condition. Pipe has been selected to be internally cleaned and inspected as part of the DMP project. (DWR Sutter Yard- AFreitag)11/16/2016 Crossing appears to be in good condition. (DWR Sutter Yard- AFreitag)04/28/2016 Crossing appears to be in good condition.07/13/2015 Crossing appears to be in good condition.  05/21/2014 Same as last inspection.12/03/2013 Same as last inspection.07/15/2013 Same as last inspection.04/18/2012 Sediment build up against flashboards. Flashboards are in use on landside of levee. FIELD_STRUCT_DESC: 24-inch corrugated metal drainage pipe through the levee, 8.2 feet below the crown. Flap gate on the waterside (WS) end. Concrete "U" headwalls on both ends. Flashboards should be present on the landside (LS). [Additional Reference(s): DWR Levee Log, 1993 (HLM 8.11). USACE Sacramento O&M Manual 519, June 1962 (HLM 8.12), As-built DWG No. 50-4-3608, Sheet No. 3608/18, STA 696+00E, page 19 of 28 electronic file, listed as 24-inch CMP; As-built DWG No 50-4-3037 referenced not available] FS Date: 8/27/2019 2:07:00 PM

Overview of levee crown at crossing looking D/S.

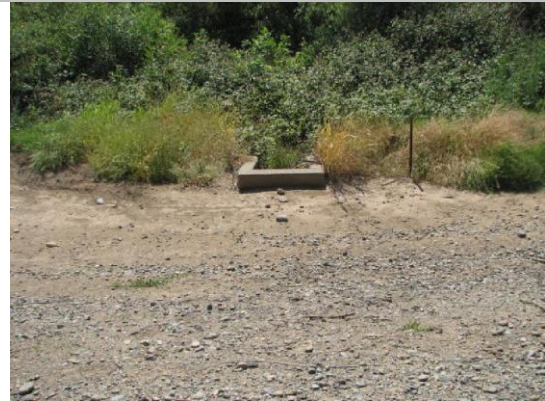
Photo 2 of 3 : UCIP\_SP\_2020\_54973\_66873.jpg

View of WS slope and toe.

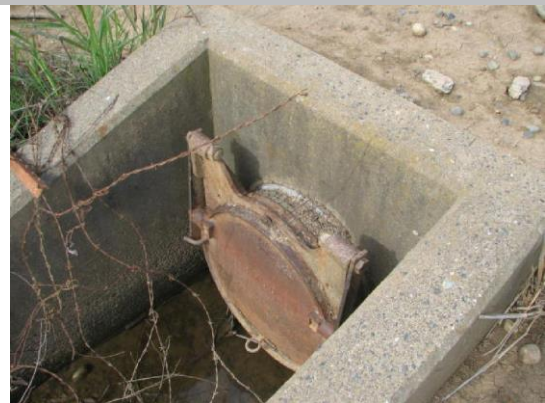
Photo 3 of 3 : UCIP\_SP\_2020\_54973\_66869.jpg

WS Flap gate

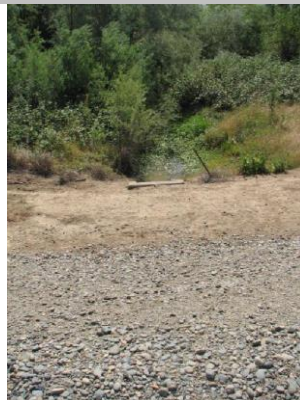
Photo 2 of 3 : UCIP\_SP\_2020\_54974\_66874.jpg

View of WS slope and toe.

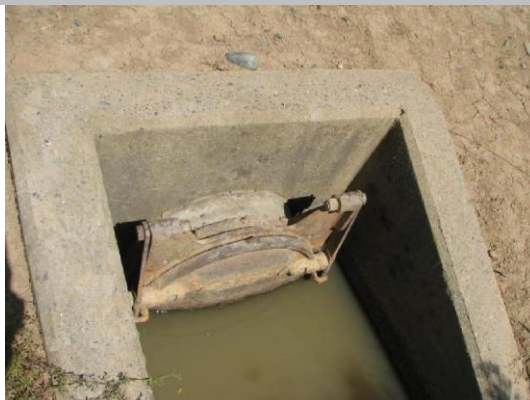
Photo 3 of 3 : UCIP\_SP\_2020\_54974\_66877.jpg

View of WS flap gate and headwall.

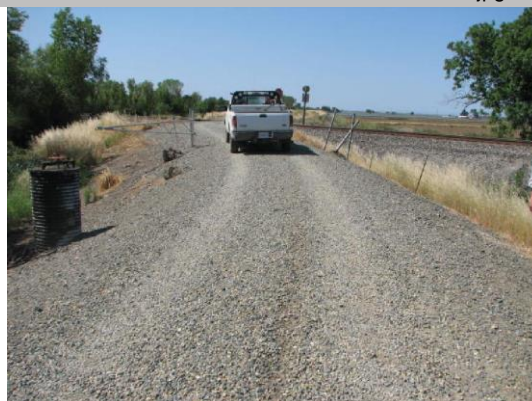
Photo 1 of 3 : UCIP\_SP\_2020\_54978\_66895.jpg

DS_ID:16325 FS_ID:54978 EP_NO: N/A Repair Type: Non-Urgent Crossing Status: Found UCIP Comments: 08/28/2019 Record remains Non-Urgent, no permit has been identified authorizing pipe. Spoke to Richvalle Irrigation District manager and he mentioned that this structure is not theirs. He recommended that LMA-Sutter Yard break lock to access crossing. Crossing appears to fit general configuration for drainage structure. (O. Magana - DWR UCIP, A. Freitag - DWR Sutter Yard)08/27/2019 No permit has been found authorizing this structure. Need to find owner. Originally assigned to LMA-Sutter Yard however, unknown locks on WS slide gates. This crossing is not maintained or operated by LMA-Sutter Yard. (O. Magana - DWR UCIP, A. Freitag - DWR Sutter Yard)06/14/2017 Debris drifts built up around the WS slide gates-needs to be cleared away. LS appears to be in good condition. Pipe has been selected to be internally cleaned and inspected as part of the DMP project. (DWR Sutter Yard- A.Freitag)11/16/2016 Crossing appears to be in good condition. (DWR Sutter Yard- A.Freitag)04/28/2016 Crossing appears to be in good condition.07/13/2015 Crossing appears in good condition. No noticeable issues to report.05/21/2014 Same as last inspection.12/03/2013 Same as last inspection.07/15/2013 LS slope has been sprayed and cleared of vegetation and is in good condition.04/18/2012 Limited inspection on LS slope due to dense vegetation. Need photo of cleared vegetation from slopes and WS headwall. Minor debris scattered on WS slope. FIELD_STRUCT_DESC: 24-inch corrugated metal drainage pipe angled through the levee, 12.6 feet below the crown. Slide gate in corrugated metal pipe riser on the waterside (WS) slope. Slide gate on the WS end. Concrete "U" headwall on both ends. [Additional Reference(s): DWR Levee Log, 1993 (HLM 8.98). USACE Sacramento O&M Manual 519, June 1962 (HLM 8.98), As-built DWG No. 50-4-3608, Sheet No. 3608/18, 20, STA 648+55.16E, page 19, 21 of 28 electronic file, listed as 24-inch CMP] FS Date: 8/27/2019 2:11:00 PM

Overview of levee crown at crossing looking D/S.

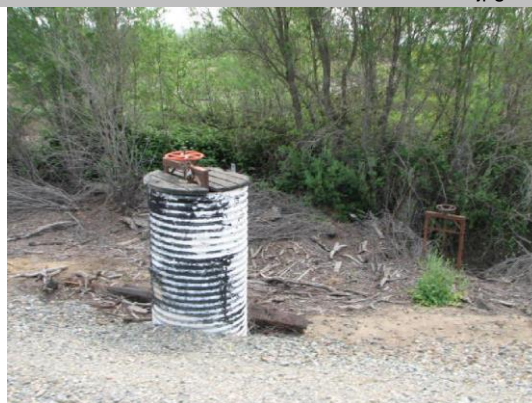
Photo 2 of 3 : UCIP\_SP\_2020\_54978\_66897.jpg

View of WS slope with 2 slide gates.

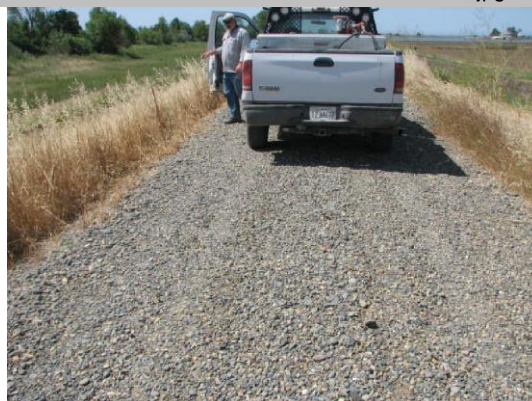
Photo 1 of 3 : UCIP\_SP\_2020\_54982\_66910.jpg

DS\_ID:16317  
FS\_ID:54982  
EP\_NO: N/A  
Repair Type: Non-Urgent  
Crossing Status: Found  
UCIP Comments: 08/27/2019 Record has been updated from No Action Needed to Non-Urgent, no permit has been identified authorizing pipe. Pipe is scheduled to be lined. (O. Magana - DWR UCIP, A. Freitag - DWR Sutter Yard)06/14/2017 Crossing appears to be in good condition. Pipe has been selected to be internally cleaned and inspected as part of the DMP project. (DWR Sutter Yard- A/Freitag)11/16/2016 Crossing appears to be in good condition. (DWR Sutter Yard- A/Freitag)04/28/2016 Crossing appears to be in good condition.07/13/2015 LS inlet has minor vegetation still. WS appears in good condition.05/21/2014 Same as last inspection.12/03/2013 Same as last inspection.07/15/2013 Slopes have been cleared of vegetation and are in good condition.04/18/2012 Limited inspection on WS and LS slopes due to dense vegetation. Need photos of cleared WS and LS slopes. This crossing was listed in the USACE Periodic Inspections as Corp's Inpect ID# USACE\_CESPK\_M13D\_2011\_p\_0278 for WS outlet sedimentation and sediment/grass at LS inlet.

FIELD\_STRUCT\_DESC: 36-inch corrugated metal drainage pipe through the levee, 10.2 feet below the crown. Flap gate on the waterside (WS) end. Concrete "U" headwalls on both ends. Flashboards should be present on the landside (LS). [Additional Reference(s): DWR Levee Log, 1993 (HLM 9.09). USACE Sacramento O&M Manual 519, June 1962 (HLM 9.09), As-built DWG No. 50-4-3511, Sheet No. 3511/28.2, STA 644+50E listed under Right Bank should be STA 644+50W, page 28 of 31 electronic file, listed as 36-inch CMP; As-built DWG No 50-4-3037 referenced not available]  
FS Date: 8/27/2019 2:13:00 PM

Overview of levee crown at crossing looking downstream.

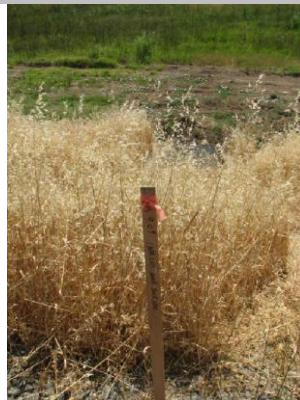
Photo 2 of 3 : UCIP\_SP\_2020\_54982\_66911.jpg

View of WS slope and toe.

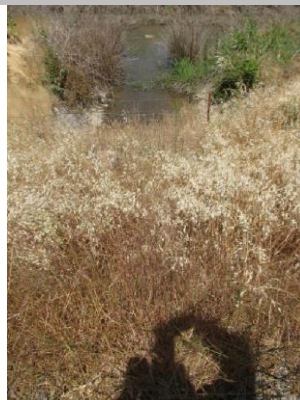
Photo 3 of 3 : UCIP\_SP\_2020\_54982\_66912.jpg

View of LS slope and toe.

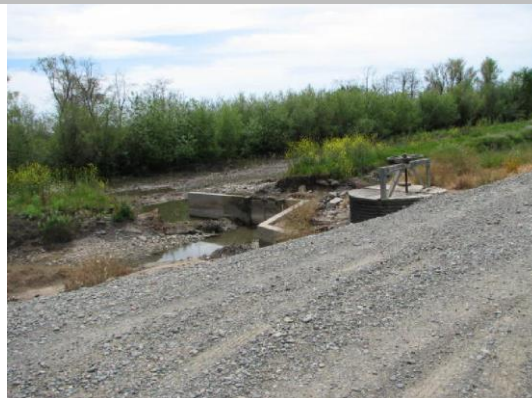
Photo 1 of 3 : UCIP\_SP\_2020\_54990\_66926.jpg

DS\_ID:16332  
FS\_ID:54990  
EP\_NO: N/A  
Repair Type: Non-Urgent  
Crossing Status: Found  
UCIP Comments: 08/27/2019 Record has been updated from No Action Needed to Non-Urgent, no permit has been identified authorizing the dual purpose of this crossing. Crossing is used as an irrigation turnout. Flow from Cherokee canal is diverted about 900 feet upstream by weir and feed into an irrigation canal that runs parallel along WS levee toe for about 2.5 miles. The irrigation turnout is used to divert water from WS irrigation canal to LS. Need to update crossing type from Drainage to Other. This crossing is not maintained or operated by LMA-Sutter Yard. (O. Magana - DWR UCIP, A. Freitag - DWR Sutter Yard)06/15/2017 Crossing appears to be in good condition. Pipe has been selected to be internally cleaned and inspected as part of the DMP project. (DWR Sutter Yard- A.Freitag)11/16/2016 Crossing appears to be in good condition. (DWR Sutter Yard- A.Freitag)04/28/2016 Crossing appears to be in good condition.07/13/2015 Crossing appears in good condition. No noticeable issues to report.05/21/2014 Same as last inspection.12/03/2013 Same as last inspection.07/15/2013 Same as last inspection.

FIELD\_STRUCT\_DESC: 60-inch corrugated metal drainage pipe through the levee, 11.5 feet below the crown. Slide gate in corrugated metal pipe riser on the waterside (WS) slope. Concrete "U" headwall on both ends and weir in channel. Crossing is used as an irrigation turnout. [Additional Reference(s): DWR Levee Log, 1993 (HLM 11.21). USACE Sacramento O&M Manual 519, June 1962 (HLM 11.21), As-built DWG No. 50-4-3511, Sheet No. 3511/10.3, STA 534+52E, page 10 of 31 electronic file, listed as 60-inch CMP through the levee; As-built DWG No. 50-4-3037 and DWG No. 50-4-3511 sht 3511/28 referenced not available]  
FS Date: 8/27/2019 2:16:00 PM

View of WS corrugated metal riser and concrete wall.

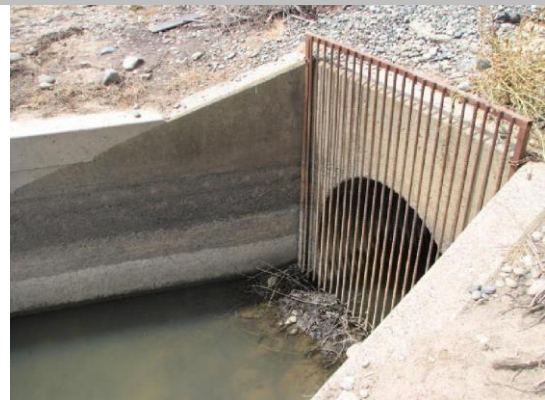
Photo 3 of 3 : UCIP\_SP\_2020\_54990\_66928.jpg

Trash rack on WS headwall.

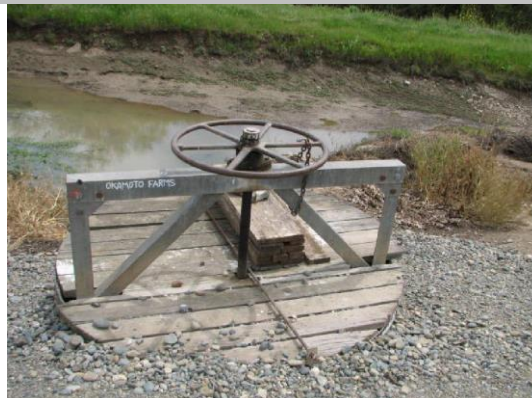
Photo 2 of 3 : UCIP\_SP\_2020\_54989\_66932.jpg

WS slide gate with owner information.

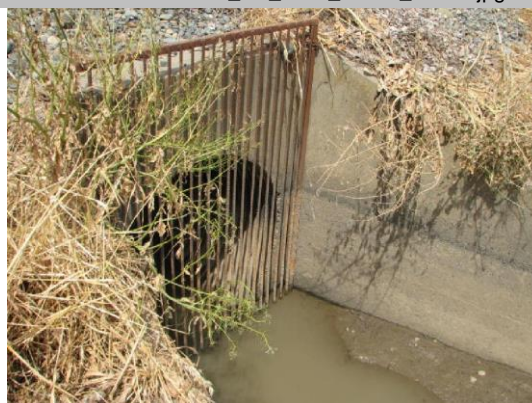
Photo 3 of 3 : UCIP\_SP\_2020\_54989\_66930.jpg

Trash rack on WS headwall.

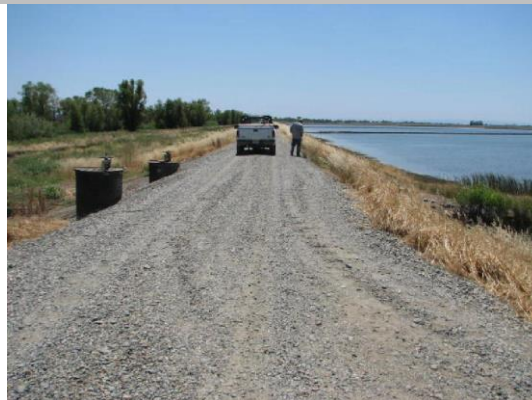
Photo 1 of 3 : UCIP\_SP\_2020\_56091\_66940.jpg

DS\_ID:16334  
FS\_ID:56091  
EP\_NO: N/A  
Repair Type: Non-Urgent  
Crossing Status: Found  
UCIP Comments: 08/27/2019 Record has been updated from No Action Needed to Non-Urgent, no permit has been identified authorizing this crossing. Irrigation siphon crosses under Cherokee Canal and Unit 2 levee at DSID 16385. (O. Magana - DWR UCIP, A. Freitag - DWR Sutter Yard)06/15/2017 WS pipe end still unknown- try to locate using GPR/ utility locator. Pipe has been selected to be internally cleaned and inspected as part of the DMP project. (DWR Sutter Yard- A.Freitag)11/17/2016 Cannot locate the WS pipe end. (DWR Sutter Yard- A.Freitag)04/28/2016 Crossing appears to be in good condition but could not locate the WS pipe end.07/13/2015 New screw gate installed inside the WS standpipe. 05/21/2014 Same as last inspection.12/03/2013 Same as last inspection.07/15/2013 Slopes have been cleared of vegetation and are in good condition. Still no sign of WS end of pipe.04/18/2012 Limited inspection on WS and LS slope due to dense vegetation. WS outlet of pipe not found. Need photos of cleared WS and LS slopes. Determine if WS outlet daylights after WS slope is cleared.

FIELD\_STRUCT\_DESC: 30-inch corrugated metal siphon pipe through the levee, 11 feet below the crown. Pipe size changes from 30-inch pipe through levee to a 24-inch pipe underneath the canal. Slide gate in corrugated metal pipe riser on the waterside (WS) slope. Concrete "U" headwall on the landside (LS). [Additional Reference(s): DWR Levee Log, 1993 (HLM 12.35). USACE Sacramento O&M Manual 519, June 1962 (HLM 12.37), listed as 30-inch pipe, As-built DWG No. 50-4-3511, Sheet No. 3511/9.3, 24.1, STA 473+86E, page 9, 24.1 of 31 electronic file, listed as combination of new 30-inch section pipe through the levee and existing 24-inch concrete siphon pipe through the channel (Keller Siphon structure, irrigation facilities); As-built DWG No. 50-4-3037 referenced not available]  
FS Date: 8/27/2019 2:17:00 PM

Overview of levee crown at crossing looking downstream.

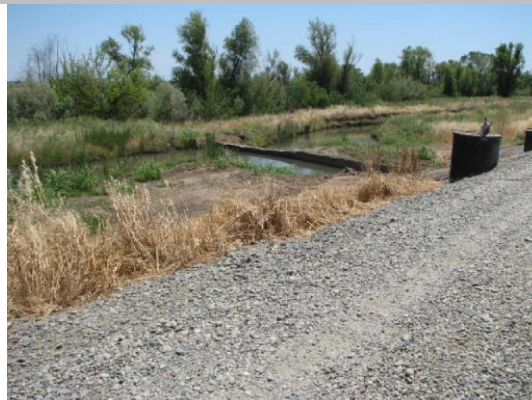
Photo 2 of 3 : UCIP\_SP\_2020\_56091\_66936.jpg

View of Ws slope and channel.

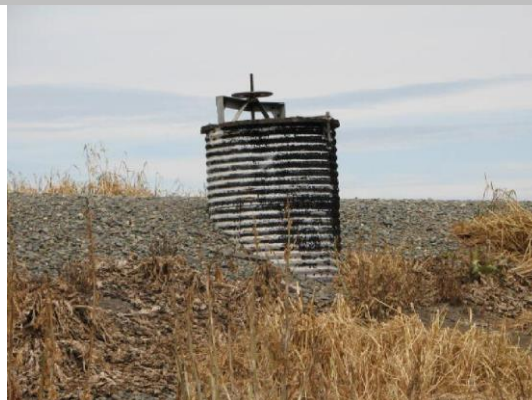
Photo 3 of 3 : UCIP\_SP\_2020\_56091\_66939.jpg

Slide gate located on WS slope.

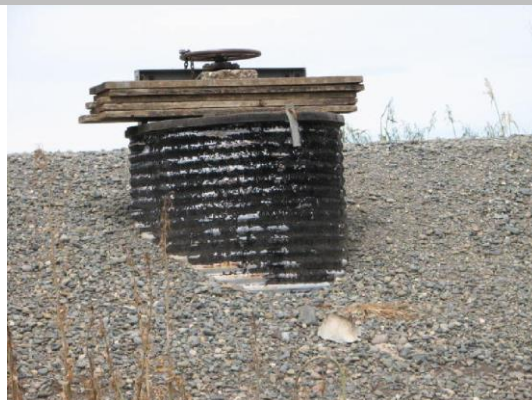
Photo 3 of 3 : UCIP\_SP\_2020\_54993\_66948.jpg

Water side screw gate located near crown hinge

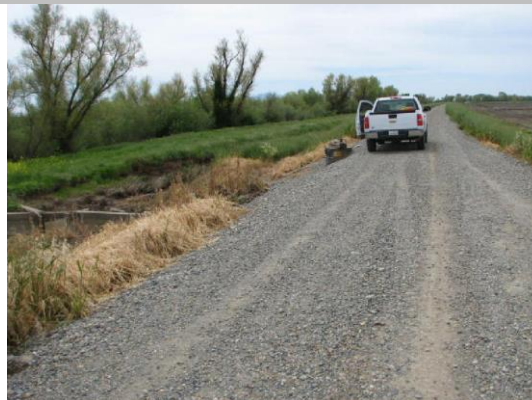
Photo 1 of 3 : UCIP\_SP\_2020\_54994\_66952.jpg

DS\_ID:16336  
FS\_ID:54994  
EP\_NO: N/A  
Repair Type: Non-Urgent  
Crossing Status: Found  
UCIP Comments: 08/27/2019 Record remains Non-Urgent, no permit has been identified authorizing the dual purpose of this crossing and slide gate is still missing from the WS CMP riser. Crossing is used as an irrigation turnout. Flow from Cherokee Canal is diverted upstream by weir and feed into an irrigation canal that runs parallel along WS levee toe for about 2.5 miles. The irrigation turnout is used to divert water from WS irrigation canal to LS. Need to update crossing type from Drainage to Other. This crossing is not maintained or operated by LMA-Sutter Yard. (O. Magana - DWR UCIP, A. Freitag - DWR Sutter Yard)06/15/2017 Slide gate still missing from inside of WS standpipe. Pipe has been selected to be internally cleaned and inspected as part of the DMP project. (DWR Sutter Yard- A.Freitag)11/17/2016 Slide gate still missing from inside the WS standpipe. (DWR Sutter Yard- A.Freitag)04/28/2016 Slide gate was removed from inside the WS standpipe.07/13/2015 New screw gate installed on the WS pipe end in the irrigation ditch.05/21/2014 Same as last inspection.12/03/2013 Same as last inspection.07/15/2013 Same as last inspection.04/18/2012 Irrigation turnout. Not in use during April 2012 Inspection. During the follow up May 2012 Inspection structure was being used as irrigation turnout, reason for barcode tags. FIELD\_STRUCT\_DESC: 30-inch corrugated metal drainage pipe through the levee, 10.7 feet below the crown. Slide gate in corrugated metal pipe (CMP) riser on the waterside (WS) slope. Concrete "U" headwalls on both ends. This crossing is used as an irrigation turnout bar code plate located on the WS slide gate (identified as 141 and 142). [Additional Reference(s): DWR Levee Log, 1993 (HLM 12.94). USACE Sacramento O&M Manual 519, June 1962 (HLM 12.94), As-built DWG No. 50-4-3511, Sheet No. 3511/8.3, STA 444+29E, page 8 of 31 electronic file, listed as 30-inch CMP; As-built DWG No 50-4-3037 referenced not available]

Overview picture looking south on right bank of Cherokee Canal.

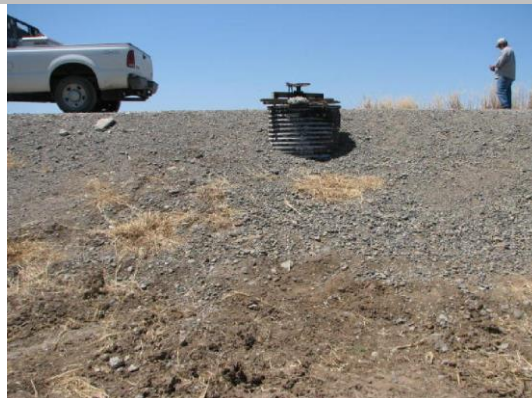
Photo 2 of 3 : UCIP\_SP\_2020\_54994\_66959.jpg

View of WS slope.

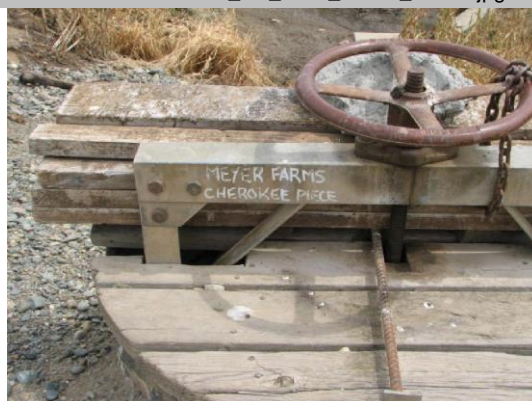
Photo 3 of 3 : UCIP\_SP\_2020\_54994\_66951.jpg

Slide gate located on WS slope. Owner information marked on gate.

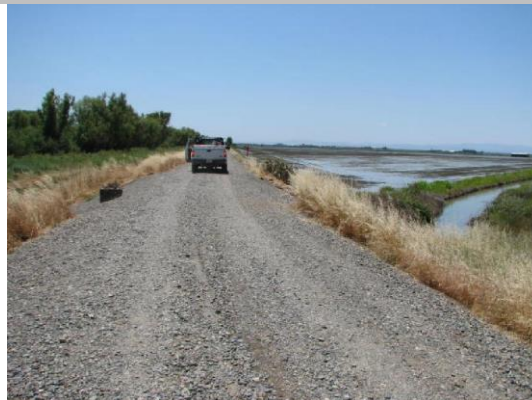
Photo 1 of 3 : UCIP\_SP\_2020\_54996\_66966.jpg

DS\_ID:16337  
FS\_ID:54996  
EP\_NO: N/A  
Repair Type: Non-Urgent  
Crossing Status: Found  
UCIP Comments: 08/27/2019 Record has been updated from No Action Needed to Non-Urgent, no permit has been identified authorizing the dual purpose of this crossing. Crossing is used as an irrigation turnout. Flow from Cherokee Canal is diverted upstream by weir and feed into an irrigation canal that runs parallel along WS levee toe for about 2.5 miles. The irrigation turnout is used to divert water from WS irrigation canal to LS. Need to update crossing type from Drainage to Other. This crossing is not maintained or operated by LMA-Sutter Yard. (O. Magana - DWR UCIP, A. Freitag - DWR Sutter Yard)06/15/2017 Crossing appears to be in good condition. Pipe has been selected to be internally cleaned and inspected as part of the DMP project. (DWR Sutter Yard- A.Freitag)11/17/2016 Ws pipe end was submerged but crossing appears to be in good condition. (DWR Sutter Yard- A.Freitag)05/03/2016 Crossing appears to be in good condition.07/13/2015 New screw gate installed inside of WS standpipe.05/21/2014 Same as last inspection.12/03/2013 Same as last inspection.07/15/2013 Same as last inspection.

FIELD\_STRUCT\_DESC: 24-inch corrugated metal drainage pipe through the levee, 11.1 feet below the crown. Slide gate in corrugated metal pipe (CMP) riser on the waterside (WS) slope. Concrete "U" headwalls on both ends. [Additional Reference(s): DWR Levee Log, 1993 (HLM 13.53). USACE Sacramento O&M Manual 519, June 1962 (HLM 13.53), As-built DWG No. 50-4-3511, Sheet No. 3511/8.3, 31.2, STA 359+08W, page 8, 31 of 31 electronic file, listed as 24-inch CMP pipe through the levee; As-built DWG No. 50-4-3037 referenced not available]  
FS Date: 8/27/2019 2:19:00 PM

Overview of levee crown at crossing looking downstream.

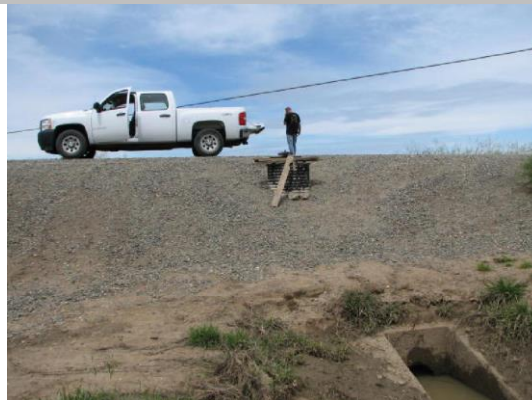
Photo 2 of 3 : UCIP\_SP\_2020\_54996\_66963.jpg

View of WS slope.

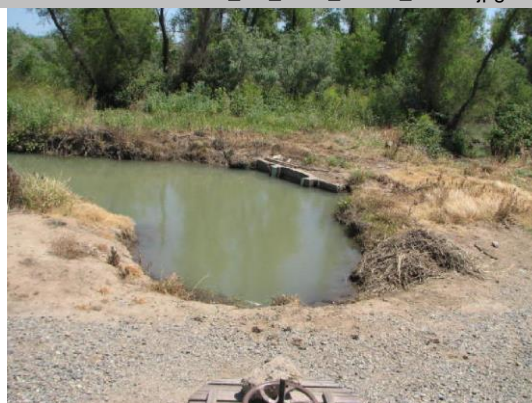
Photo 3 of 3 : UCIP\_SP\_2020\_54996\_66967.jpg

View of WS slope and channel.

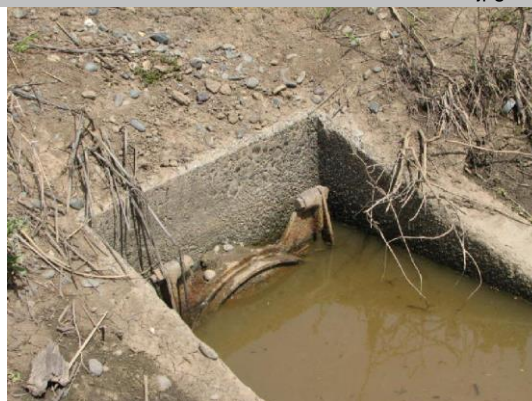
Photo 1 of 3 : UCIP\_SP\_2020\_54997\_66970.jpg

UCIP Comments: 08/27/2019 Record remains Non-Urgent, no permit has been identified authorizing pipe. Pipe is scheduled to be lined. (O. Magana - DWR UCIP, A. Freitag - DWR Sutter Yard)08/23/2018 WS flap gate has been replaced. LS outlet still has a lot of vegetation, but overall levee integrity looks good at time of this inspection.

Downgrading to Non-Urgent from Urgent due to fixed flap gate and current levee condition (D. Sanoski - DWR UCIP).06/15/2017 Not abandoned- WS flap gate was dug out and opened draining water from the LS ditch. WS flap gate is heavily corroded and has a broken hinge- needs to be replaced. LS is still very overgrown and needs to be cleared. Pipe has been selected to be internally cleaned and inspected as part of the DMP project. (DWR Sutter Yard- A.Freitag)11/17/2016 Appears abandoned. WS flap gate completely silted over and LS screw gate is completely overgrown by a tree and is not accessible for inspection. (DWR Sutter Yard- A.Freitag)05/03/2016 Crossing appears to be abandoned. WS flap gate was completely silted over and LS slide gate is very overgrown by a tree.07/13/2015 WS flap gate is blocked from opening by sediment and vegetation. Needs to be cleared away. LS opening is being over grown by a tree and needs to be cutback.05/22/2014 Same as last inspection.12/03/2013 Same as last inspection.07/15/2013 Same as last inspection.04/18/2012 Tree has fallen at LS inlet and damaged slide gate. The tree needs to be removed and screw gate repaired. Limited inspection on LS due to fallen tree.

FIELD\_STRUCT\_DESC: 24-inch corrugated metal drainage pipe angled through the levee, 12.7 feet below the crown. Flap gate on the waterside (WS). Concrete "U" headwall on both ends. [Additional Reference(s): DWR Levee Log, 1993 (HLM 13.96). USACE Sacramento O&M Manual 519, June 1962 (HLM 13.96), As-built DWG No. 50-4-3511, Sheet No. 3511/7. unable to read exact page, STA 336+56W, page 7 of 31 electronic file, listed as 24-inch CMP]  
FS Date: 8/27/2019 2:19:00 PM

WS headwall and flap gate.

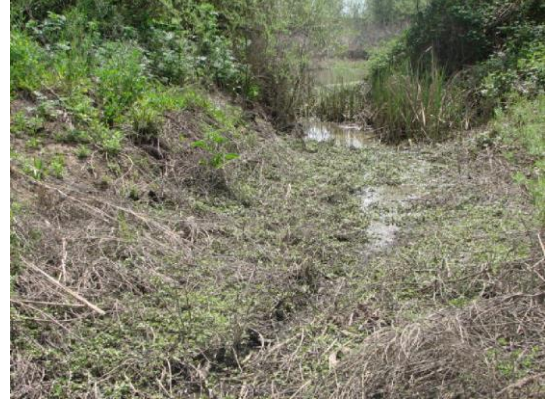
Photo 2 of 3 : UCIP\_SP\_2020\_54997\_66971.jpg

View of channel at crossing.

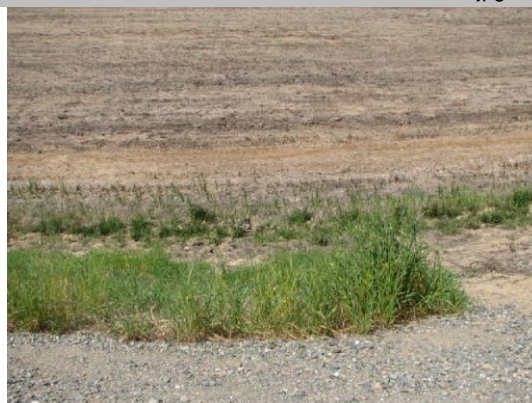
Photo 2 of 3 : UCIP\_SP\_2020\_54998\_66973.jpg

DS\_ID:16339  
FS\_ID:54998  
EP\_NO: N/A  
Repair Type: Non-Urgent  
Crossing Status: Found  
UCIP Comments: 08/27/2019 Record remains Non-Urgent, crossing has been abandoned. Need to update crossing type from Drainage to Irrigation. Crossing was used as a irrigation line and not drainage. This crossing is not maintained or operated by LMA-Sutter Yard. (O. Magana - DWR UCIP, A. Freitag - DWR Sutter Yard)06/15/2017 Abandoned- still only the structure on the WS shoulder found. (DWR Sutter Yard- A.Freitag)11/17/2016 Abandoned. (DWR Sutter Yard- A.Freitag)05/03/2016 ABANDONED CROSSING07/13/2015 Abandoned crossing. Slide gate is buried on the WS.05/22/2014 Same as last inspection.12/03/2013 Same as last inspection.07/15/2013 Same as last inspection.04/18/2012 Non-functional crossing-buried slide gate on WS. Limited inspection on WS and LS slope/toe due to dense vegetation. Need photo of cleared WS & LS slopes or toe. This crossing is listed in the USACE periodic inspection report as Corp's Inspection ID# USACE\_CESPK\_M13D\_2011\_p\_0352 for abandoned gate on WS slope.

View of LS slope and toe. Unable to find welded plate on LS.

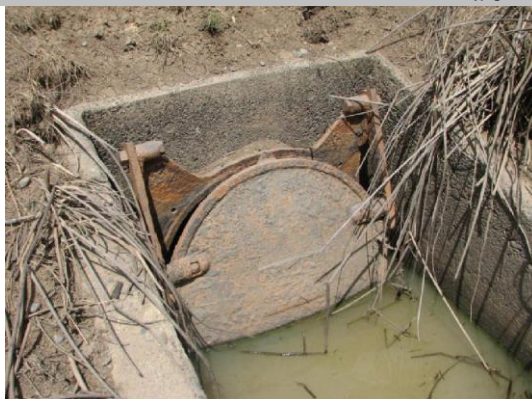
UCIP Comments: 08/27/2019 Record remains Urgent due to pipe integrity and levee integrity issues. Previously noted holes on the pipe collar located at WS have been sealed using splash zone epoxy. Two holes (possible sink holes) were observed behind WS concrete headwall. Recommend internal inspection of pipe through levee to determine if sink holes are attributed to holes in pipe. (O. Magana - DWR UCIP, A. Freitag - DWR Sutter Yard)08/23/2018 WS pipe unable to be inspected due to heavy vegetation at inlet, so assume same as last inspection. Noticed a long crack a couple feet above WS headwall that could be of concern; possible future slough if soil gets saturated during next high water event and could be a sign of internal pipe degradation. LS outlet and slope looked good. Urgent due to long crack, obstructed inspection view of WS inlet, and 2016 photos of holes in pipe (D. Sanoski - DWR UCIP).06/15/2017 WS pipe end still showing heavy signs of corrosion and deterioration with visible holes between the concrete headwall and flap gate flange. Pipe was almost 100% full of water so could not visually inspect inside of the pipe to see if theres any damage inside of the levee segment. Pipe has been selected to be internally cleaned and inspected as part of the DMP project. (DWR Sutter Yard- A.Freitag)11/17/2016 Top of pipe on WS still showing heavy signs of corrosion with visible holes between the flap gate flange and the concrete headwall. The pipe was mostly underwater so could not internally inspect it for more damage or corrosion. (DWR Sutter Yard- A.Freitag)05/03/2016 Top of the pipe on the WS has holes in it between the flap gate flange and headwall. Crossing is showing signs of rust and deterioration but it was mostly underwater so could not inspect the inside of the pipe. (DWR Sutter Yard - afreitag)07/13/2015 Both sides of crossing were underwater at the time of inspection. (DWR Sutter Yard - afreitag)05/22/2014 Same as last inspection. (DWR Sutter Yard - afreitag)12/03/2013 Same as last inspection. (DWR Sutter Yard - afreitag)07/15/2013 Slopes have been cleared of vegetation and are in good condition. WS flap gate is still lodged open. (DWR Sutter Yard - afreitag)04/18/2012 Limited inspection on LS slope due to dense vegetation. Need photos of cleared WS & LS slopes. The flap gate is lodged open. (DWR UCIP - omagana)

Headwall and flapgate located on water side of levee

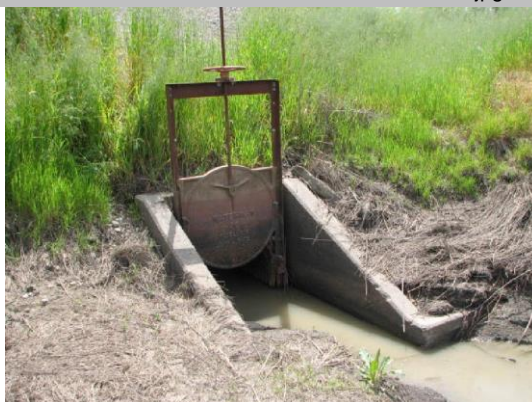
Photo 3 of 3 : UCIP\_SP\_2020\_54999\_66975.jpg

Head wall and screw gate located on land side of levee

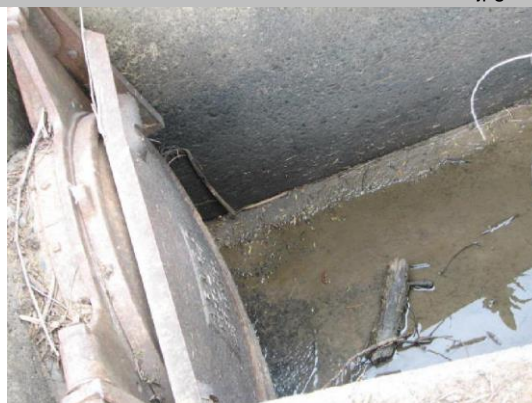
Photo 1 of 3 : UCIP\_SP\_2020\_55000\_66981.jpg

Comment Code					
Inspector Comment					
DS_ID:16367 FS_ID:55000 EP_NO: N/A Repair Type: Non-Urgent Crossing Status: Found UCIP Comments: 08/27/2019 Record has been updated from No Action Needed to Non-Urgent, no permit has been identified authorizing pipe. Pipe is scheduled to be lined. (O. Magana - DWR UCIP, A. Freitag - DWR Sutter Yard)06/15/2017 Crossing appears to be in good condition. Pipe has been selected to be internally cleaned and inspected as part of the DMP project. (DWR Sutter Yard- AFreitag)11/17/2016 Crossing appears to be in good condition. (DWR Sutter Yard- AFreitag)05/03/2016 Crossing appears to be in good condition.07/13/2015 Crossing appears in good condition. No noticeable issues to report.05/22/2014 Same as last inspection.12/03/2013 Same as last inspection.07/15/2013 Slopes have been cleared of vegetation and are in good condition.04/18/2012 Limited inspection on WS and LS slope due to dense vegetation. Need overall photo of crossing and photos of cleared WS & LS slopes. FIELD_STRUCT_DESC: 36-inch corrugated metal drainage pipe through the levee, 12.4 feet below the crown. Concrete "U" headwalls on both waterside (WS) and landside (LS). Flap gate on the waterside (WS) end. [Additional Reference(s): DWR Levee Log, 1993 (HLM 15.12). USACE Sacramento O&M Manual 519, June 1962 (HLM 15.12), As-built DWG No. 50-4-3511, Sheet No. 3511/6. unable to read exact page, STA 276+00W, page 6 of 31 electronic file, listed as 36-inch CMP; As-built DWG No. 50-4-3037 referenced not available] FS Date: 8/27/2019 2:21:00 PM

WS headwall and flapgate

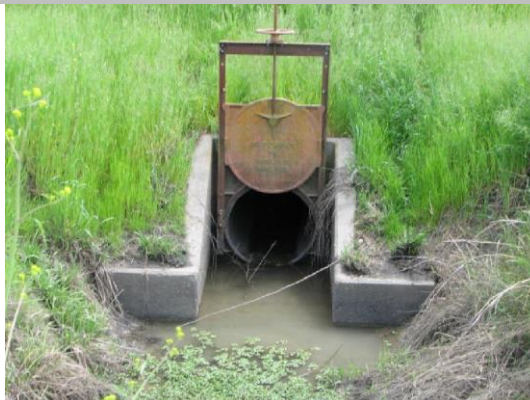
Photo 2 of 3 : UCIP\_SP\_2020\_55000\_66980.jpg

Slide gate located on LS toe. Dense vegetation present on LS slope.

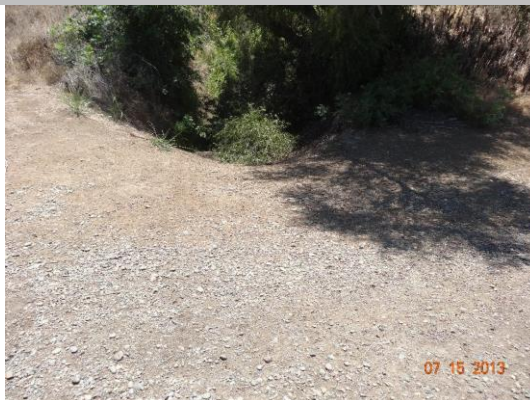
Photo 3 of 3 : UCIP\_SP\_2020\_55000\_66982.jpg

WS slope cleared of vegetation
